Manhole Inspection Summary

Manhole # S43A2_033MH

Location Address: **3607 West Bay Ave**

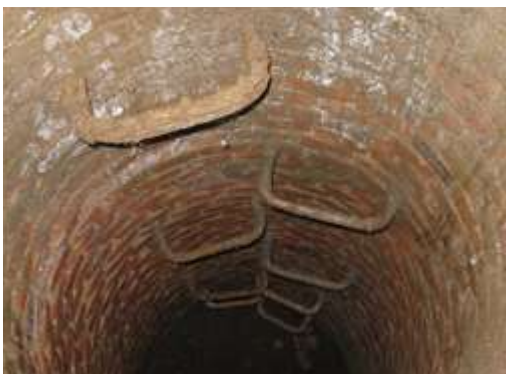
Steps

Count: **8** Missing: **0** ☐ Corroded

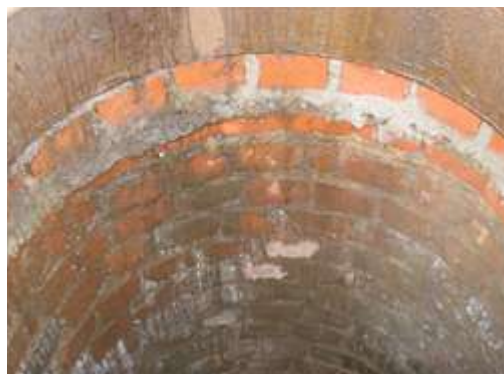
Defect 2

Infiltration: ☐ None ☐ Joint ☐ Cracks ☒ Mortar ☐ Roots ☐ Wall

Mortar

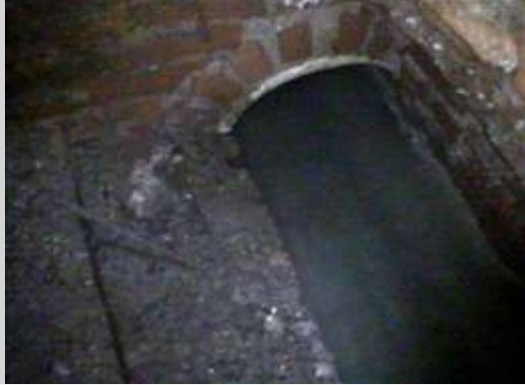
12 O'Clock Outflow

15 in. Circular Gravity Sewer
Pipe Out @ 12 O'Clock

Pipe Height: **14.4** (in.) Rod and Bar (Angled)
Pipe Material: **Clay** ☐ Pipe Lined
Invert Depth: **17.06** (ft.) Flow Characteristics: **Slow**
Deposits: ☒ None ☐ Mud ☐ Sludge ☐ Debris ☐ Grease
Silt Depth: (in.) Deposits Extent:
Infiltration: **None** Pipe Seal Cond: **Sound**

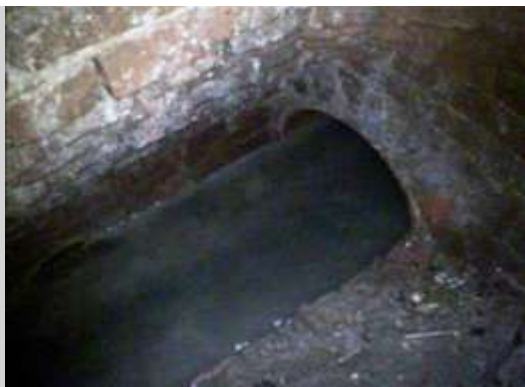
6 O'Clock Inflow

15 in. Circular Gravity Sewer
Pipe In @ 6 O'Clock

Pipe Height: **14.4** (in.) Rod and Bar (Angled)
Pipe Material: **Clay** ☐ Pipe Lined
Invert Depth: **16.98** (ft.) Flow Characteristics: **Slow**
Deposits: ☒ None ☐ Mud ☐ Sludge ☐ Debris ☐ Grease
Silt Depth: (in.) Deposits Extent:
Infiltration: **None** Pipe Seal Cond: **Sound**
